Avoiding Falsework Failure

Course Content

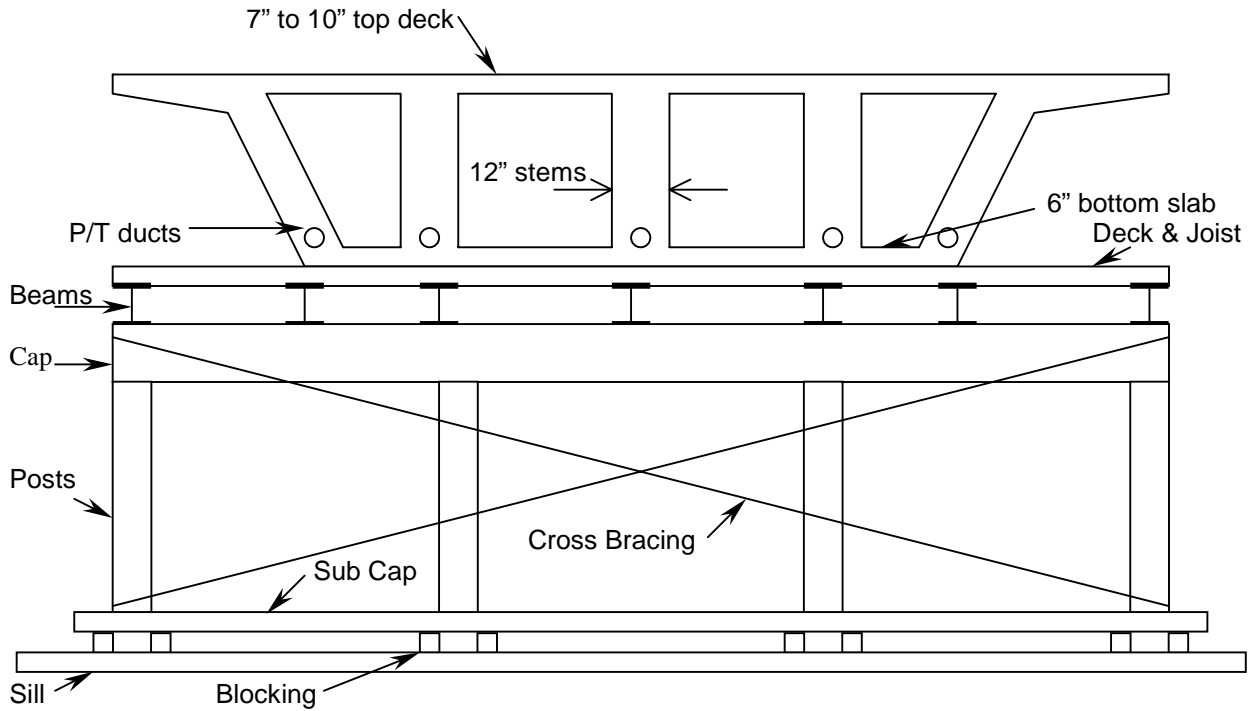
A common freeway type bridge is the post-tensioned concrete box girder as sketched below:

TYPICAL BRIDGE SECTION

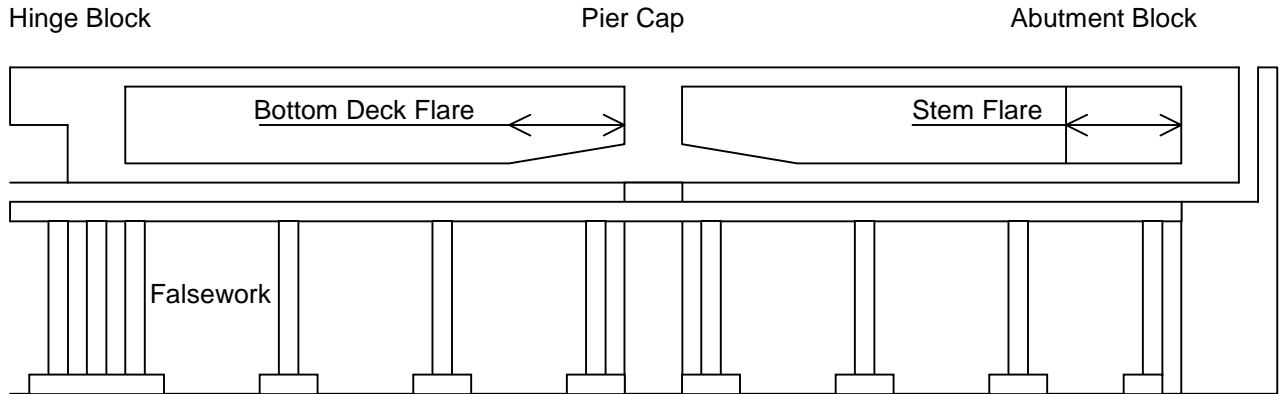
Please note that closely spaced falsework posts are shown at the hinge. The reason for this is the bridge superstructure box will camber upward when post-tensioned. The mid-span falsework will be unloaded and the bridge weight transferred to the pier, abutment and hinge support. This causes the hinge support falsework to support 30 to 50% of the total hinge span weight; depending on a number of bridge configuration elements.

TYPICAL LONGITUDNAL SECTION

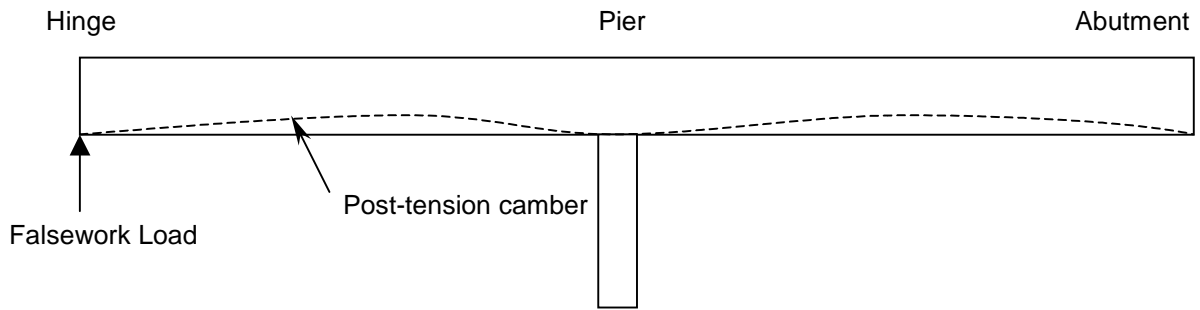
CAMBER DIAGRAM

This very large load concentrated on the hinge falsework means that crushing of the soffit joist timber must be considered. Web crippling of the beams and caps must be analyzed. This falsework must be left in place until the load can be transferred to the next segment of the bridge. The potential of long term loading and severe weather conditions causes a careful consideration of the bearing soil condition and possible long term settlement.

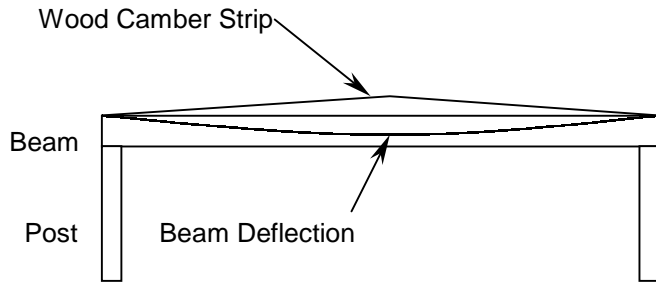
Between the joist and the beam is commonly placed a camber strip. This camber strip is usually a triangular wedge that will keep the bottom deck on grade as the beam deflects under the weight of the bottom deck and stems plus the form and beam weights. The width of the camber strip is determined to prevent rolling and perpendicular to the grain timber crushing pressures from developing.

BEAM CAMBER STRIP

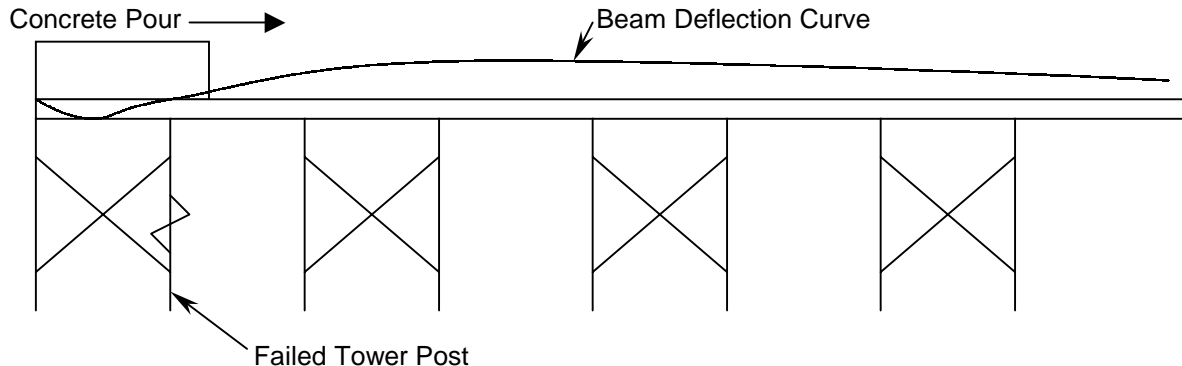
There have been instances where long beams have contributed to falsework failures due to the pour sequence. In one case a heavy slab supported by 10K "Tinker Toy" shoring towers was caused to fail because the beam deflection in a partially completed pour transferred too much load to a tower leg. The leading end of the long beam actually lifted off the towers and transferred all the form and rebar weight to the leg under the leading edge of the concrete pour.

LONG SPAN DIAGRAM

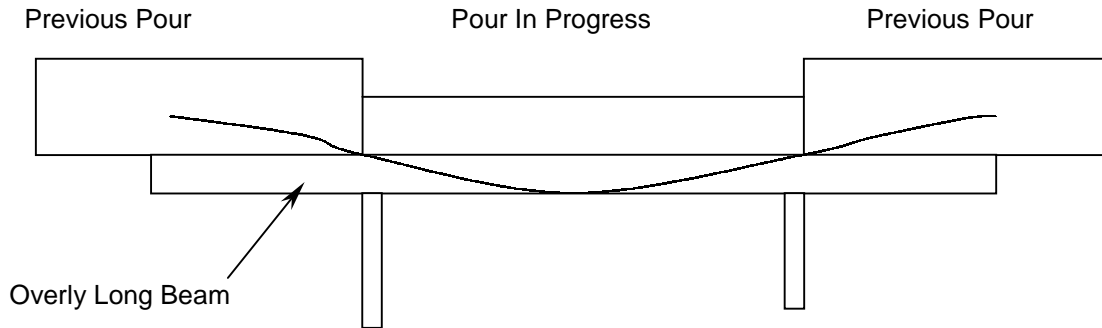
In another case, overly long beams caused excessive settlement by transferring excessive load to the posts. Fortunately, this was discovered in time to prevent a collapse. The Posts were designed to support only the pour in progress. The pour in progress caused the tips of the beam to deflect upward and transferred the weight of the previous pours to the posts.

OVERLY LONG SIMPLE SPAN BEAM

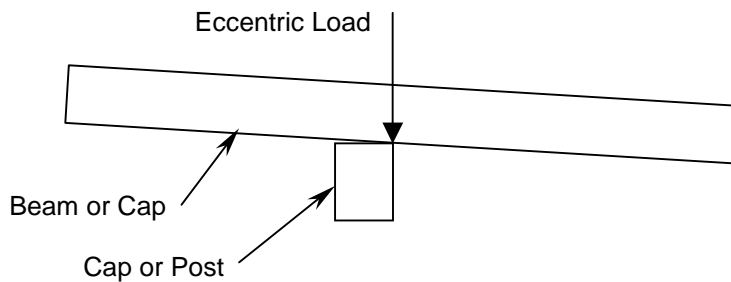
Bridges are often designed with varying grades, curves and superelevation slopes. This creates several issues that must be resolved.

SUPERELEVATION & GRADE SLOPE DIAGRAM

The eccentric loading can cause lateral bending of the beams webs and induce bending moments into the posts. Wedging can be employed, but a two-way rocker bearing on the post is the preferred solution. Because the bridge bottom deck is commonly on a significant slope, squat and compact beams are preferred, such as a W14x90 shape. Because of the eccentric effects the bending stress of steel should be limited to 0.6 of the steel yield strength.

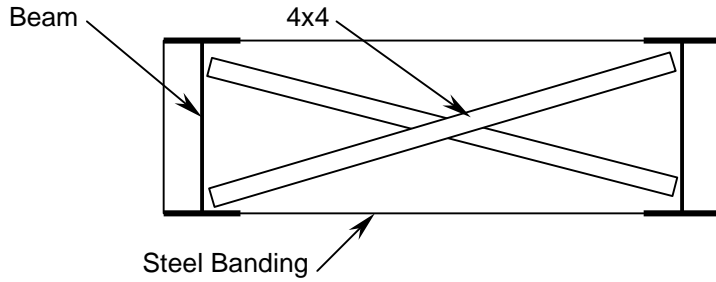
Lateral bracing should be used to keep the steel beams in a supported compact length. On severe transverse slopes the beams should be laterally supported at least near the supports and at mid-span. This can be easily accomplished with crossed 4x4 and steel banding.

LATERAL BRACING OF BEAMS

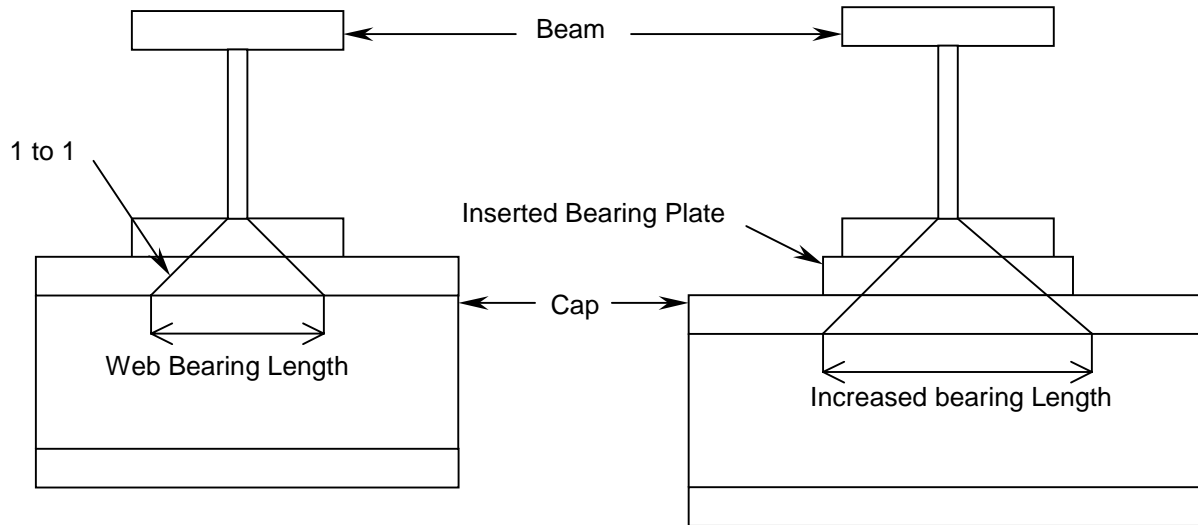
A significant consideration is web crippling of steel and aluminum shapes. It is expensive to install stiffeners and they must be accurately located. This limits the flexibility of the placement of crossing member as well as the reuse to another location. It is common to insert bearing plates between crossing beams to distribute the point loads. The plates are easily placed and make for an inexpensive solution to the web crippling issue.

BEAM WEB CRIPPLING

PLATE ADDED TO INCREASE BEARING LENGTH

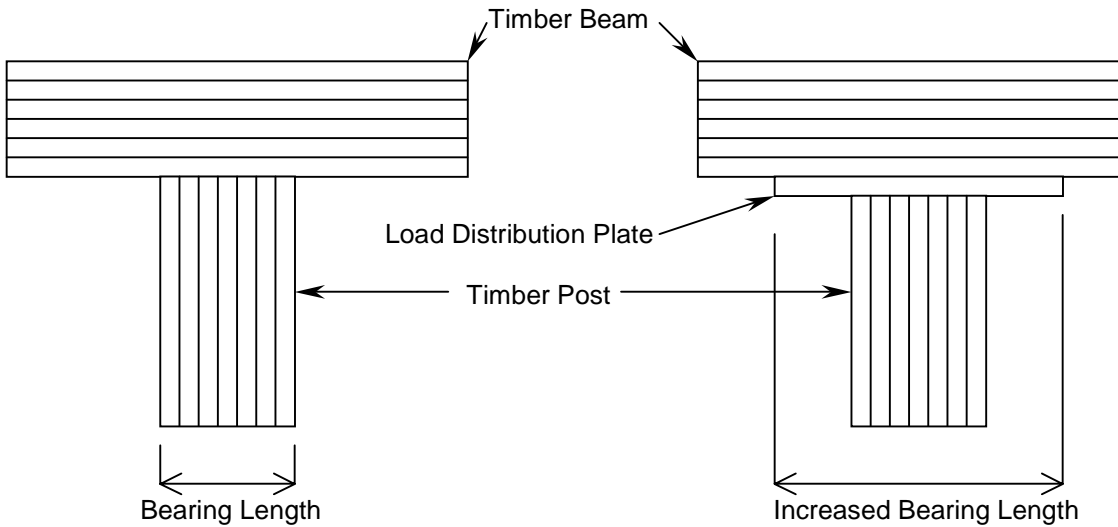
Just as steel plates can be used to distribute the web crippling loads in steel beams, plates can be easily inserted to distribute the crushing loads in timber beam to post connections. The added consideration is that the plate thickness must be designed to carry the distributed crushing load in bending.

BEAM CRUSHING

PLATE ADDED TO INCREASE BEARING LENGTH

Timber crushing is a concern due to the fact that the perpendicular to the grain allowable bearing stress is on the order of 25 % of the parallel to the grain allowable bearing stress. Timber properties such as the modulus of elasticity and crushing resistance is greatly reduced by water saturation. It is recommended that the wet properties of timber be used for design criteria. Rain, clean up, and dust

control and curing water will likely soak into the timber members. Crushing of heavy timber, such as 12x12 can easily cause unacceptable settlements. I have seen such timber crush as much as 2 inches.

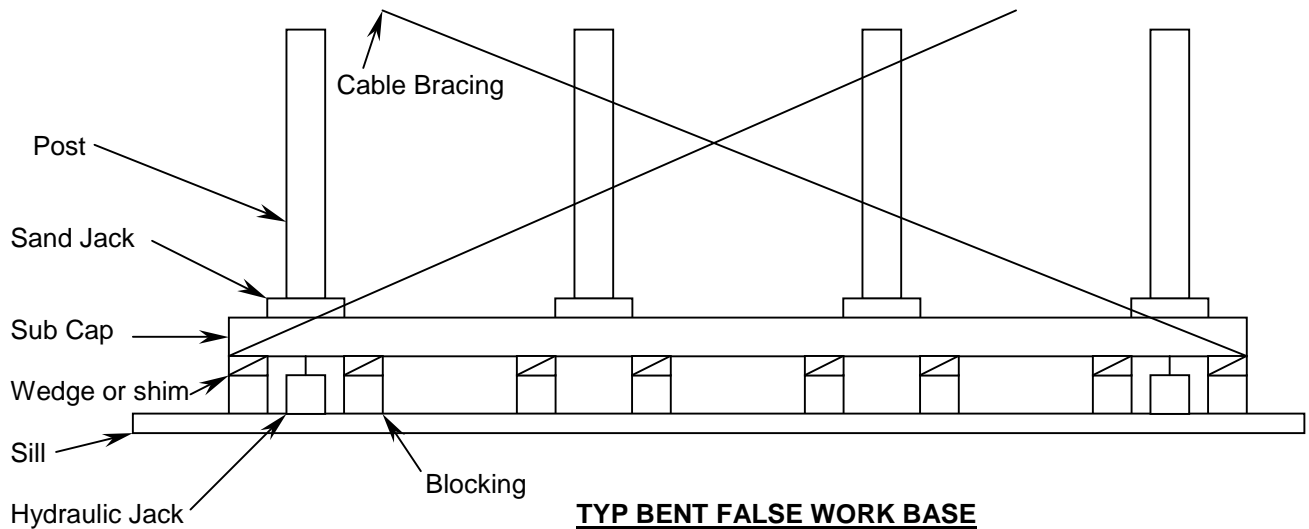
The sub cap serves several purposes. It anchors the cable cross bracing so that the entire falsework bent acts as a frame. If the cable is attached to a post, the lateral force can pull the post over causing a collapse of the falsework. The sub cap also aids in establishing the final soffit grade. Usually the falsework is erected an inch or two low and then jacked into final grade after the soffit plywood is installed. This also reduces the number of grade points. Trying to grade every beam end high in the air is a nearly hopeless task.

The sand jacks are not needed at all bents. At mid span the post-tensioned induced upward camber may be enough to release the bridge weight. At piers and especially at the hinge point a release mechanism is required to remove the bridge weight so that falsework can be easily stripped. A sand jack is a can containing sand. Removal of the can allows the sand to flow away and slowly lower the post to release the load.

The sub cap allows the soffit to be raised to final grade with only two jack points per falsework bent. Once final grade is established, the gap between the blocking and sub cap is packed with shims or wedges. The gap between the blocking and sub cap during jacking or release should always be minimal. Falsework collapses have occurred when the hydraulic jack failed and allowed a sudden drop of the falsework. During the jacking and release the falsework should be adequately braced laterally in all directions.

Double blocking is shown in the above diagram. This serves to reduce crushing pressure and more evenly distributes the loads on to the sill. This reduces the sill timber or concrete thickness.
